Grading Report

Make	Toyota	Model	Fortuner
YOM	2022	Odo Meter Reading	52,789
Registration No.	NFL1711	Chassis No.	MHFAA8GS7N0774703
CC	2.8	Transmission	A/T
Fuel Type	Diesel	Type of Body	SUV
Colour	White

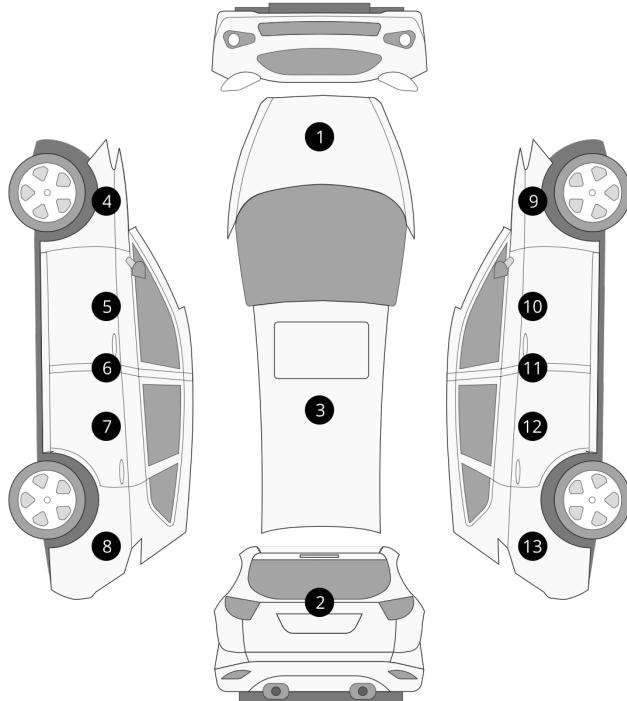
Body / Panel Condition

#	Area	Thickness(um)			
		Average	Value1	Value2	Value3/4
1	Bonnet	128.6	129	125	132
2	Boot Lid	151.0	187	133	133
3	Roof	130.2	131	137	141/112
4	Left Front Fender	129.3	141	119	128
5	Left Front Door	129.3	128	129	131
6	Center Panel Left				
7	Left Rear Door	119.6	120	125	114
8	Left Back Panel	127.0	133	122	126
9	Right Front Fender	131.3	155	111	128
10	Right Front Door	134.0	133	131	138
11	Center Panel Right				
12	Right Rear Door	132.0	140	118	138
13	Right Back Panel	134.3	137	124	142

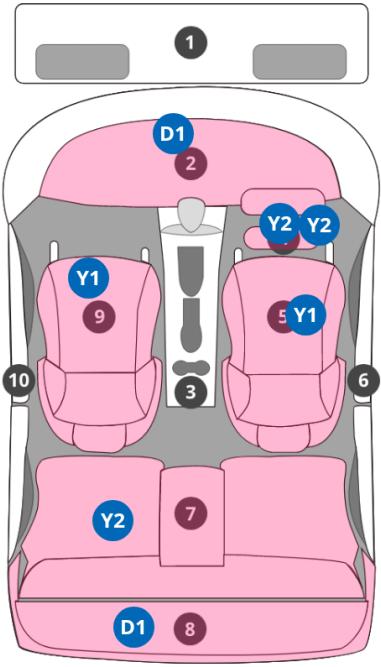
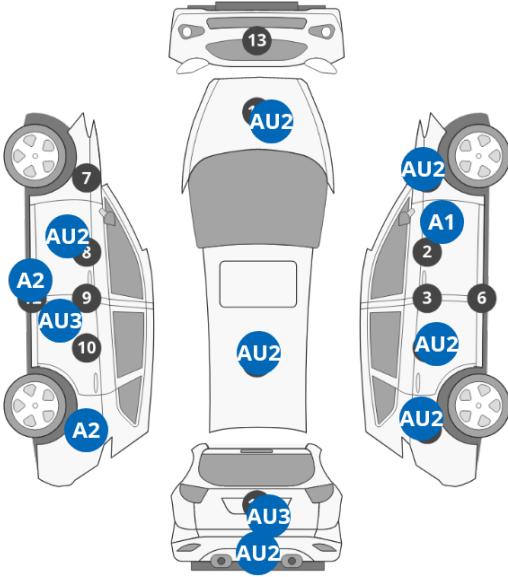
Interior Evaluation :	B	Exterior Evaluation :	C

a : Cut, Fray d : Loose, Deformed k : Animal Hair s : Smell t : Cigarette Burns x : Defective y : Stain			A : Scratch AU : Scratch & Dent B : Modified C : Corrosion G : Stone chip P : Faded S : Rust SC : Rust & Corrosion U : Dent X : Defective Y : Crack, Gap
Remarks (L) Front Seat - Grime - Minimal / (R) Front Seat - Grime - Minimal / (L) Front Floor Mat - Grime - Small / (R) Front Floor Mat - Grime - Small / Dashboard - Worked - Minimal / Rear Seat - Grime - Small / Trunk Room - Worked - Minimal			Remarks (L) Front Door, Molding - Scratch & Dent - Small / (L) Step, In-panel, Side Spoiler - Scratch - Small / (L) Rear Door, Molding - Scratch & Dent - Medium / (L) Rear Fender, Molding - Scratch - Small / Rear Bumper, Lamps, Panels - Scratch & Dent - Small / Trunk Hood, Rear Gate - Scratch & Dent - Medium / (R) Rear Fender, Molding - Scratch & Dent - Small / (R) Front Door, Molding - Scratch & Dent - Small / (R) Step, In-panel, Side Spoiler - Scratch - Minimal / (R) Front Fender, Molding - Scratch & Dent - Small / Bonnet, Headlight - Scratch & Dent - Small / Roof - Scratch & Dent - Small
